Deliverable T2.4.1 – Formulation and lab test of eco-solutions to be implemented in Bowling South Falkirk pilot site report

30 January 2020

Richard Lord, Keith Torrance, Ignas Jakstys & Alasdair Hamilton

University of Strathclyde and Scottish Canals

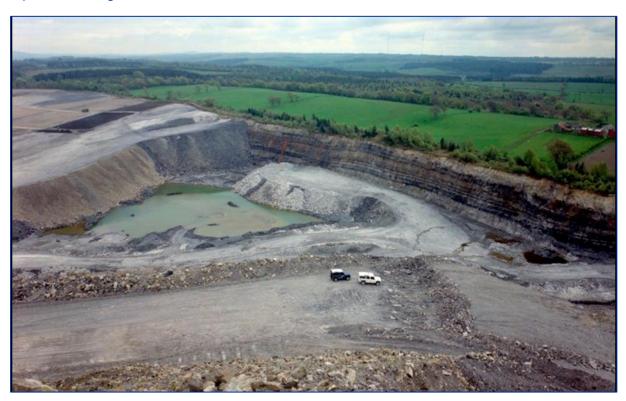
Figure 3. 1993 Photo of Roughcastle mine looking southeast showing the underlying geology. British Geological Survey. P000221.

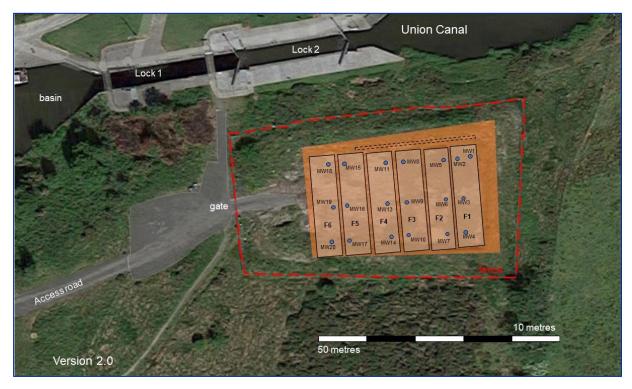
Figure 4. Plan showing the cell boundaries and position of monitoring wells.

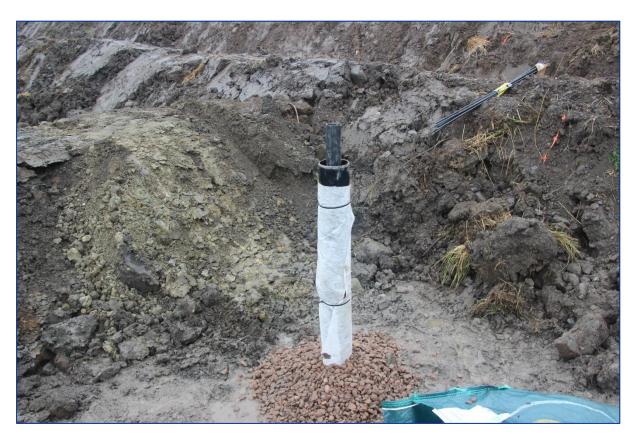
Figure 21. Construction of monitoring well/piezometers.

to a length of approximately 140cm. 1.5mm transverse slots were cut into the bottom 50cm of the pipe to allow water to infiltrate the well. The pipe was encased within a 110mm diameter PVC pipe, cut to a length of 110cm, that was perforated for the bottom 50 cm of its length using a hand drill with a 10 mm bit. A 40cm x 60cm sleeve of a construction geo-fabric was installed to cover the perforations and held in place using zip ties (Figure 21).

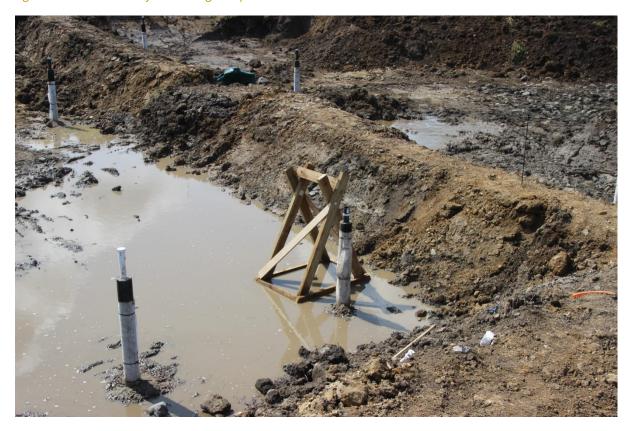
Figure 22. MW01 and MW02 in cell F2 showing A-frame in position.

As the dredged sediment had the consistency of wet sludge the safety of personnel during measurement was the prime concern. Adjacent to each well point was placed a wooden A-frame (Figure 22) which was constructed using scrap timber. The A-frame

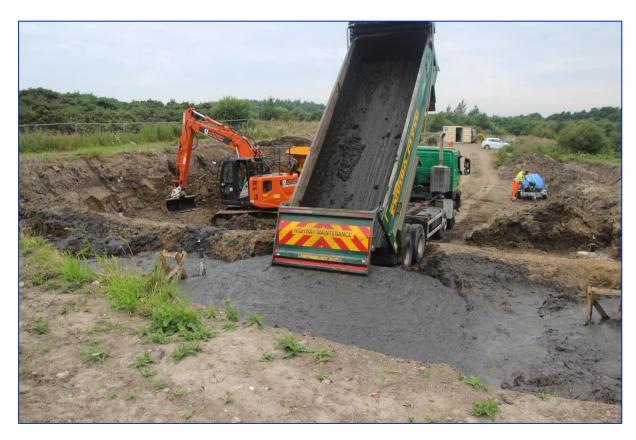
Figure 23. Dredged sediment being dumped into Cell F1.

Each load was discharged directly to the centre of the cell in a single operation (Figure 23). The large loader was then used to re-distribute the sediment to the ends of the cell, taking care not to disturb the wells. During the filling of cell F1 there was some movement of both the wells and the A-frames. Subsequently, sand bags were used to anchor the A-frames and additional ballast placed around the base of the wells to reduce any movement of the well assembly from the vertical (Figure 32). No further issues with well movement were experienced. The depth of sediment in cells F1 to F5 varied from 0.7 metres to 1.0 metres. Cell F6 was filled to less than 20% of capacity but may be used for future excavations. The monitoring wells in this cell were not used.

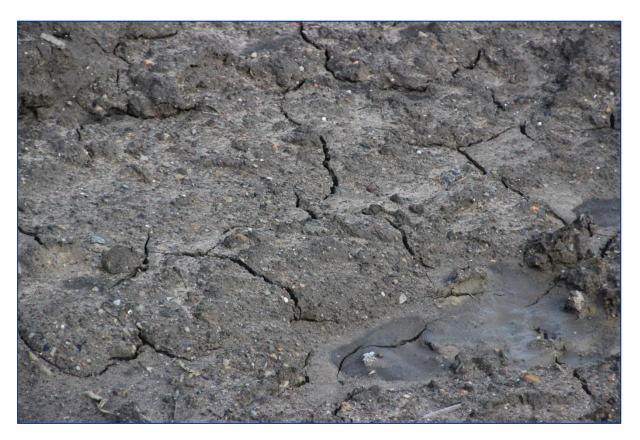
Figure 31. Onset of de-watering with desiccation cracks on top layer of sediment around the edges of cell F1.

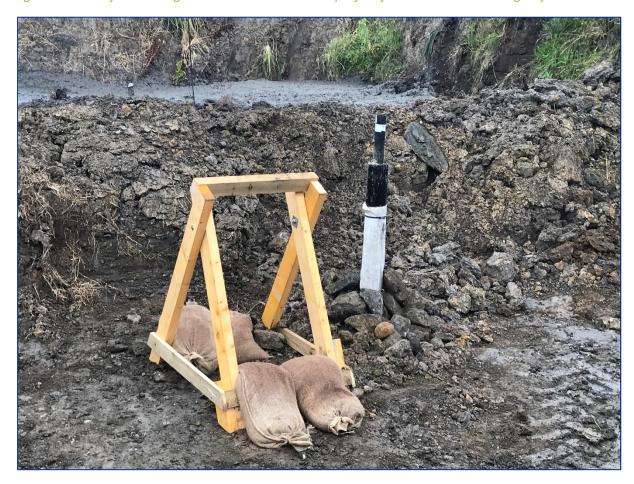
Figure 32. Well MW7 with A-frame anchored using sand bags.

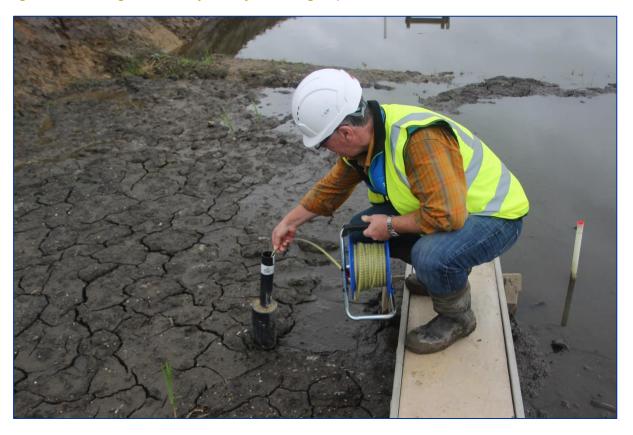
Figure 38. Measuring depth to water at MW7 in Cell F2 using water level meter.

TD-Diver[©] water level data loggers⁵ were installed in MW2, MW5 and MW15 at a depth of approximately 1 metre below the top of casing (TOC). The Divers[©] autonomously recorded groundwater levels and temperature at intervals of 15 minutes. Data was collected from each Diver[©] by removing it from the well and retrieving the data via an optical interface with a USB connector to a computer loaded with Diver-Office software. Water levels in wells that were not fitted with a Diver[©] were gauged in the conventional manner using a water level sounder at regular intervals (Figure 38).

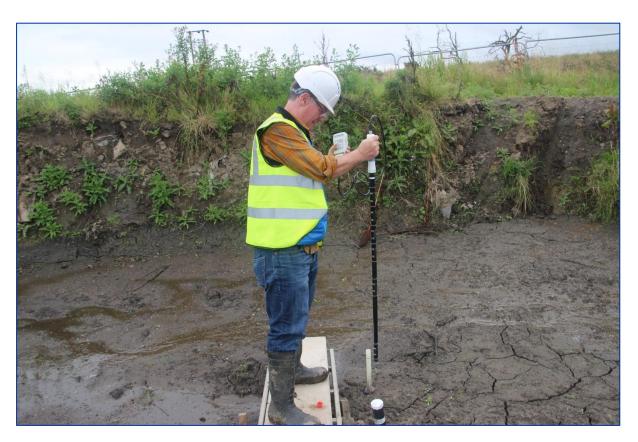
Figure 39. Moisture probe (PR2/6) prior to insertion into pre-installed fiberglass sleeve.

Close to each well, a 1-metre long fiberglass sleeve was pushed into the wet sediment, tapped down and capped. This sleeve was designed to accept a one-metre long PR2/6 TDR moisture probe⁶ connected to a data logger which measured moisture at six vertical intervals in the sediment. Data were collected using a portable data-logger connected to the moisture probe (Figure 39). In practice, the sleeves couldn't be installed flush with cell surface level so at least two sensors were above ground level. The height of the top of the sleeve was determined by surveying so that the elevation of each sensor was known for all locations.

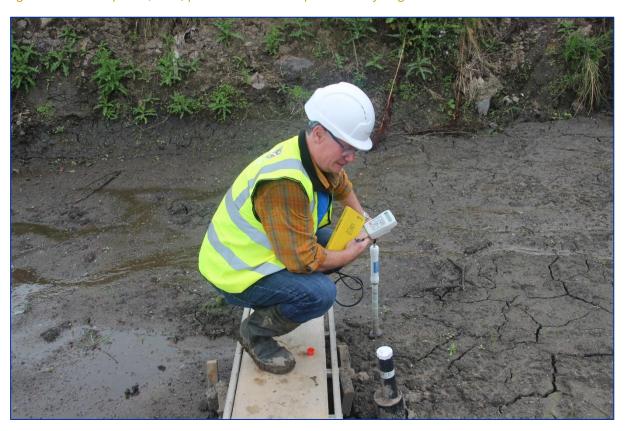
Figure 40. In-situ measurement of soil moisture at six horizons using soil moisture probe and moisture meter.

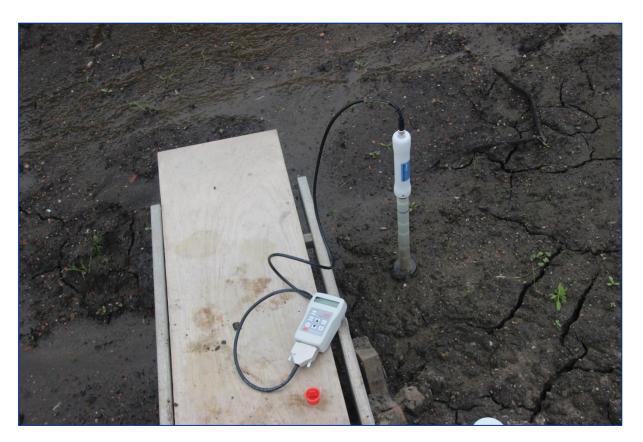
Figure 41. PR2/6 soil moisture probe with HH2 moisture meter.

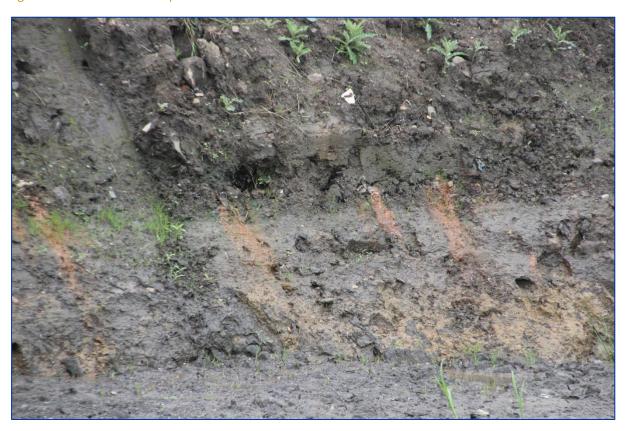
Figure 42. Evidence for the ingress of soil water from the up gradient part of the site.

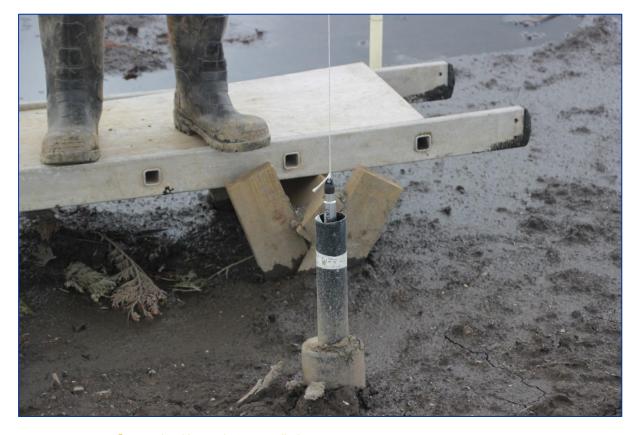
Figure 44. TD-Diver[©] water level logger being installed in MW5.

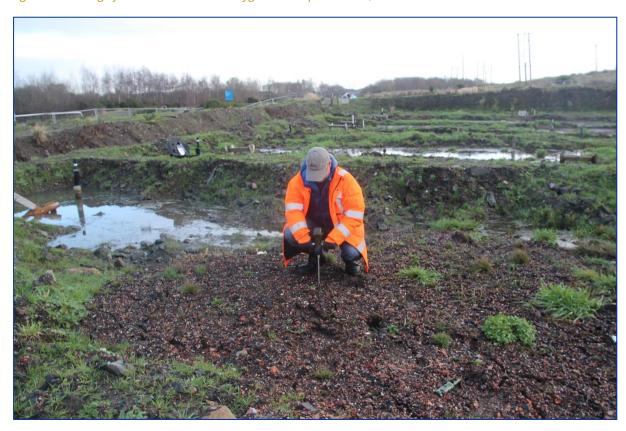
Figure 48. Using the MEXE cone penetrometer to determine soil strength in cell F6.

A MEXE Soil Assessment Cone Penetrometer, Model SL 137¹² was used for in-situ soil testing at the end of the trial (Figure 48). This instrument is designed for assessing fine-grained soils. A 20mm diameter cone attached to the device was pushed into the ground and the resistance noted. This reading can be used to estimate the California Bearing Ratio (CBR) of the subsurface, which is a measure of its compressive strength. Results are shown in Table 5. For comparison, a typical target strength for a road subgrade is 2 (200%) CBR (Cook & Dobie, 2016). CBR values of 5-80% can be expected for different types of natural soils, with improvement from 30% to 50% for marine sediments amended with lime or cement for road construction (Wang et al. 2012).

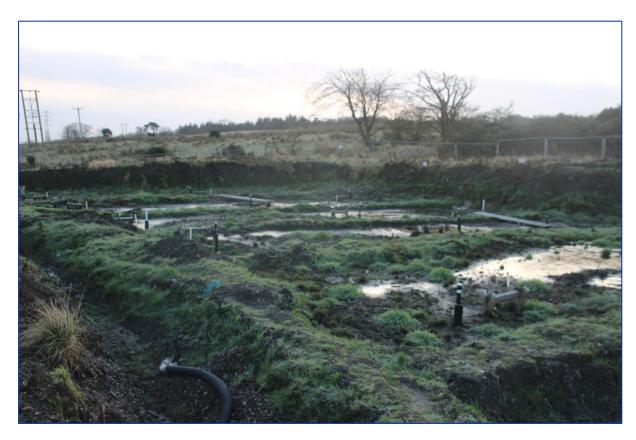
Figure 49. View of the site on January 17th 2020 showing the degree of re-vegetation within the cells.

By the end of the pilot trial in January 2020 there was considerable plant growth (Figure 49), including isolated clumps of RCG. However, there was no discernible new growth RCG from the seeds that were planted in September. This may be due to the late autumn planting, competition with established plant species or poor seed stock quality. Appendix C provides a visual record of changes to the appearance of each cell through from dewatering and vegetation growth.
